# Manhole Inspection Summary

Manhole # S25C\_\_013MH

Insp Date: **8/2/07 10:57 AM**

**Location** Address: **1302 FRANKLIN ST**

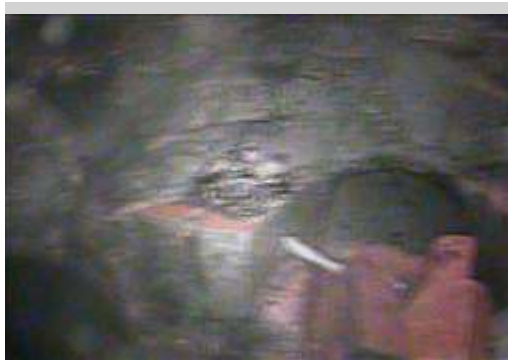
Comments **abandoned pipe at i9**

abandoned pipe i9

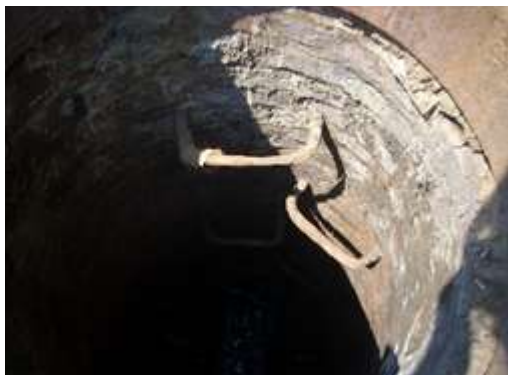
Defect 3

☒ **Evidence Of Surcharge** Depth: **5** (ft.) ☐ Active Surcharge Present

SURCHARGE EVIDENCE ON THE STEPS

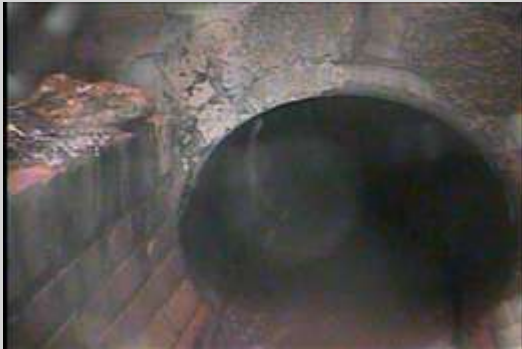
12 O'Clock Outflow

21 in. Circular Gravity Sewer  
Pipe Out @ 12 O'Clock

Pipe Height: **21.6** (in.) Rod and Bar (Angled)  
Pipe Material: **Clay** ☐ Pipe Lined  
Invert Depth: **13.51** (ft.) Flow Characteristics: **Fast**  
Deposits: ☒ None ☐ Mud ☐ Sludge ☐ Debris ☐ Grease  
Silt Depth: (in.) Deposits Extent:  
Infiltration: **None** Pipe Seal Cond: **Sound**

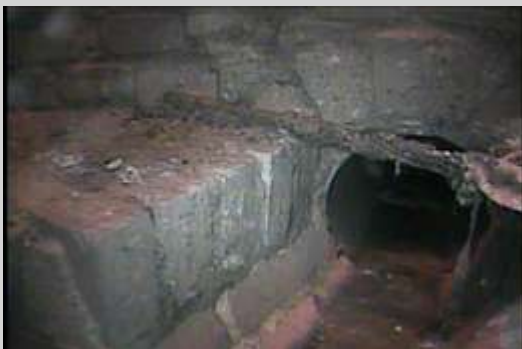
3 O'Clock Inflow

8 in. Circular Gravity Sewer  
Pipe In @ 3 O'Clock

Pipe Height: **7.2** (in.) Rod and Bar (Angled)  
Pipe Material: **Clay** ☐ Pipe Lined  
Invert Depth: **12.37** (ft.) Flow Characteristics: **Slow**  
Deposits: ☒ None ☐ Mud ☐ Sludge ☐ Debris ☐ Grease  
Silt Depth: (in.) Deposits Extent:  
Infiltration: **None** Pipe Seal Cond: **Sound**

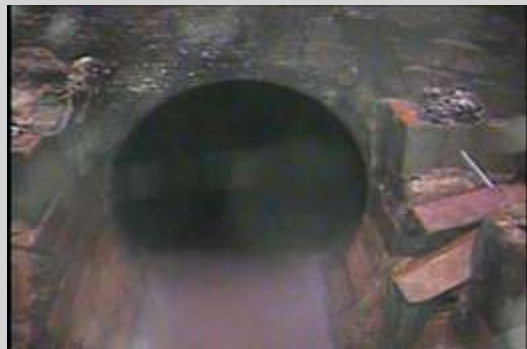
6 O'Clock Inflow

21 in. Circular Gravity Sewer  
Pipe In @ 6 O'Clock

Infiltration: **None** Pipe Seal Cond: **Sound**
